**CERCLA
EXPANDED SITE INSPECTION ADDENDUM REPORT**

Eagle Zinc Company

Hillsboro, Montgomery county, Illinois

September 1, 2005

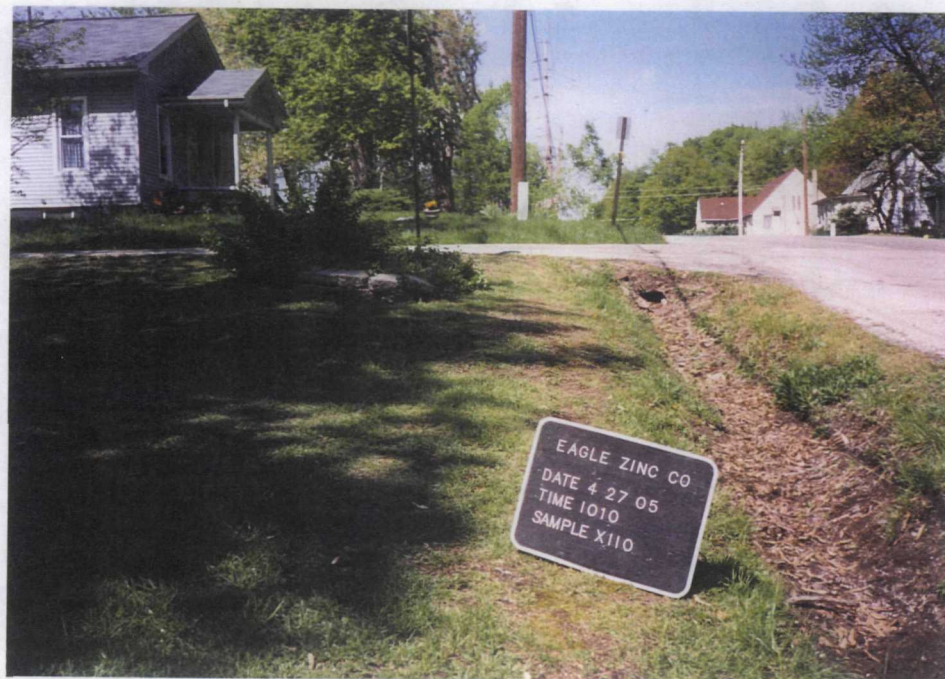
DATE: 4/27/05
TIME: 10:10
PHOTOGRAPH TAKEN BY: R. CASPER
COMMENTS: Picture taken toward: West.
Photo Number 48.
Sample X110. The sample consisted of gravel, black fill material, cinders and metal pieces.
